Portage Creek Sediment Remediation Project Kalamazoo, Michigan

Post-Sediment Removal Structure Feature Assessment
Removal Areas SA1-A, SA1-B and SA1-C

F&V Project Number: 809930
October, 2013

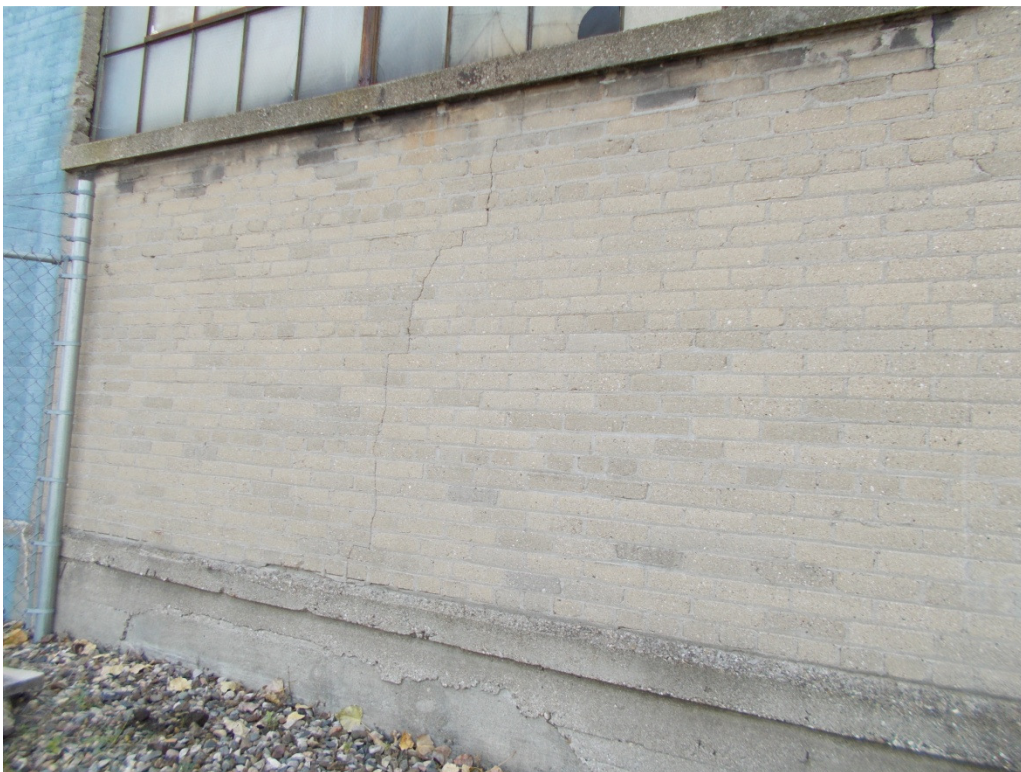
Cracking in wall appears unchanged

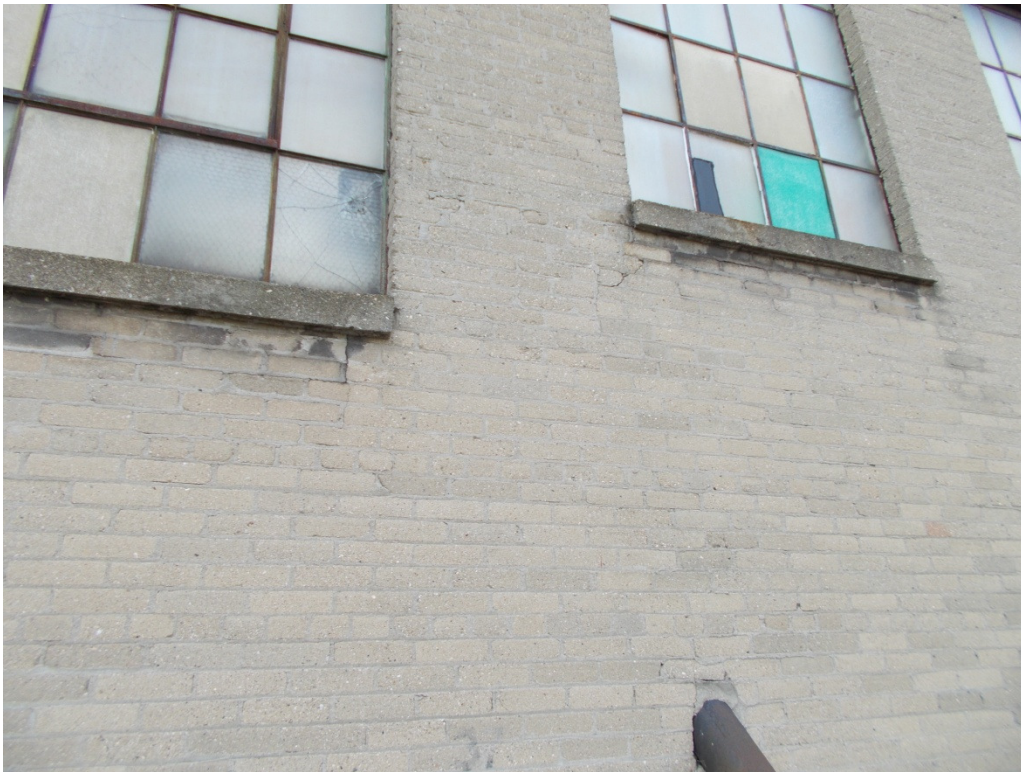
Cracking in wall appears unchanged

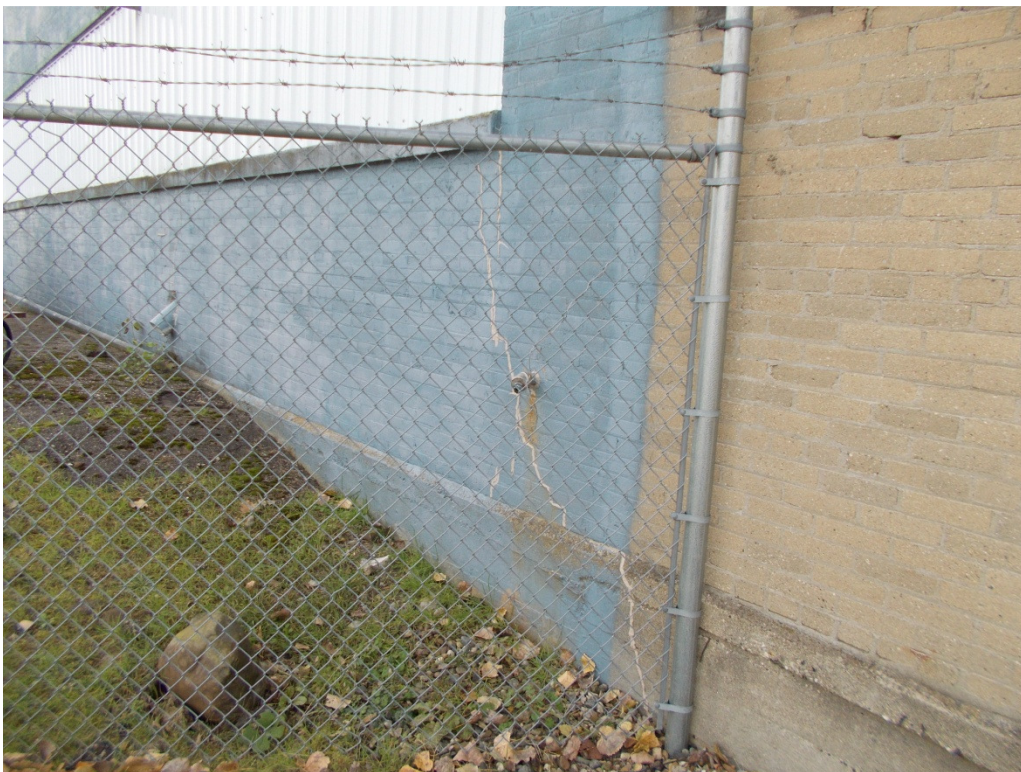
Cracking in wall appears unchanged

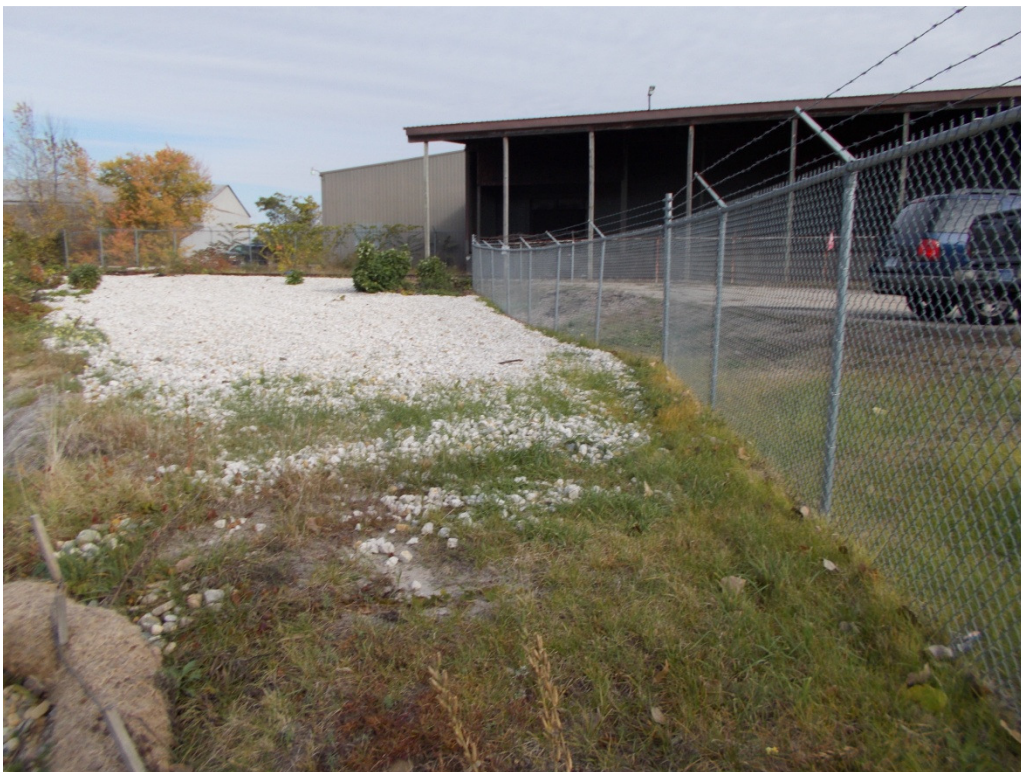
- The bank along the northern area of the fence has been restored with riprap.
- The structure does not appear to have been impacted during sediment removal.

View of fence looking north with new riprap restoration

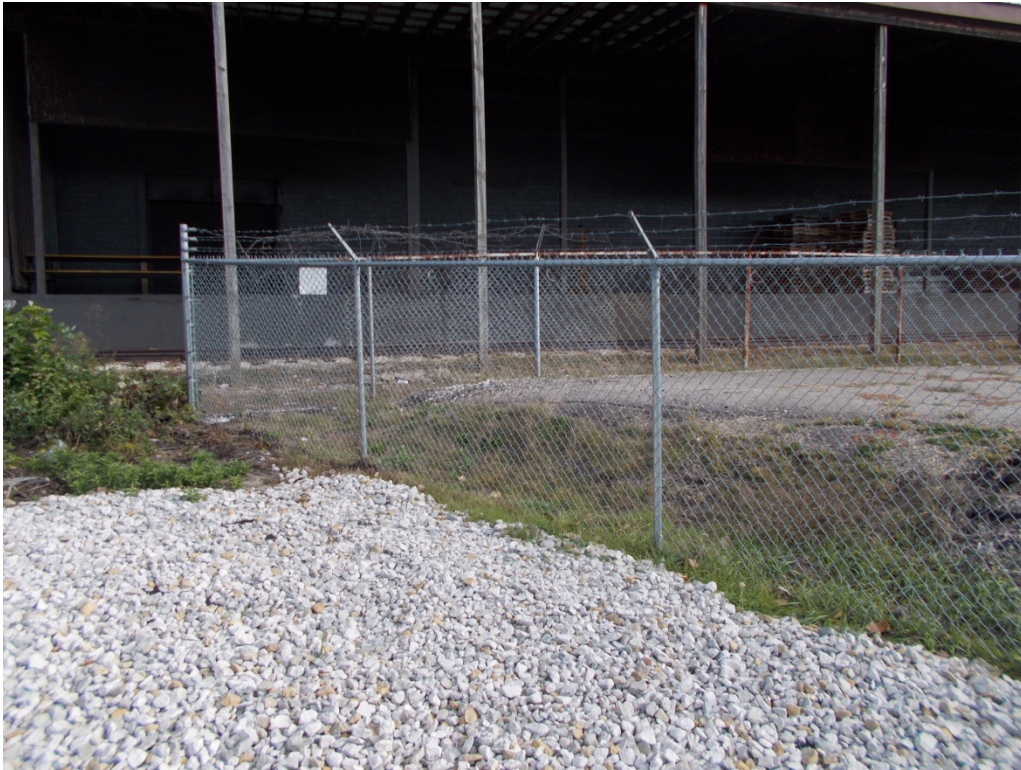
Failed barb wire at north end of fence

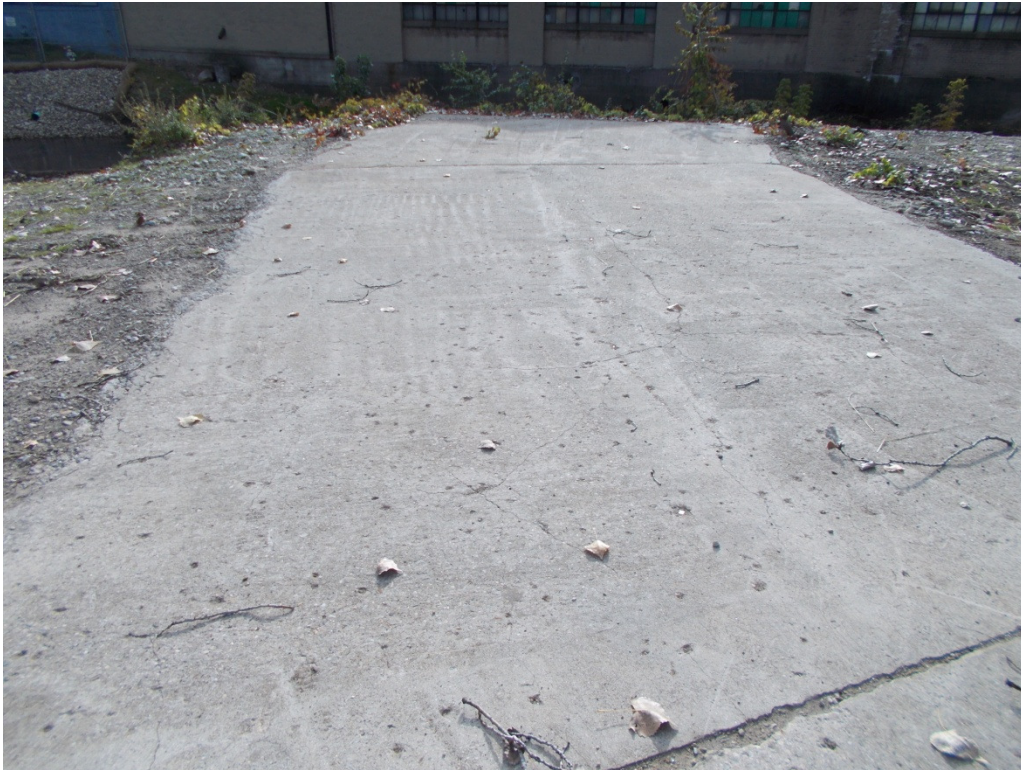
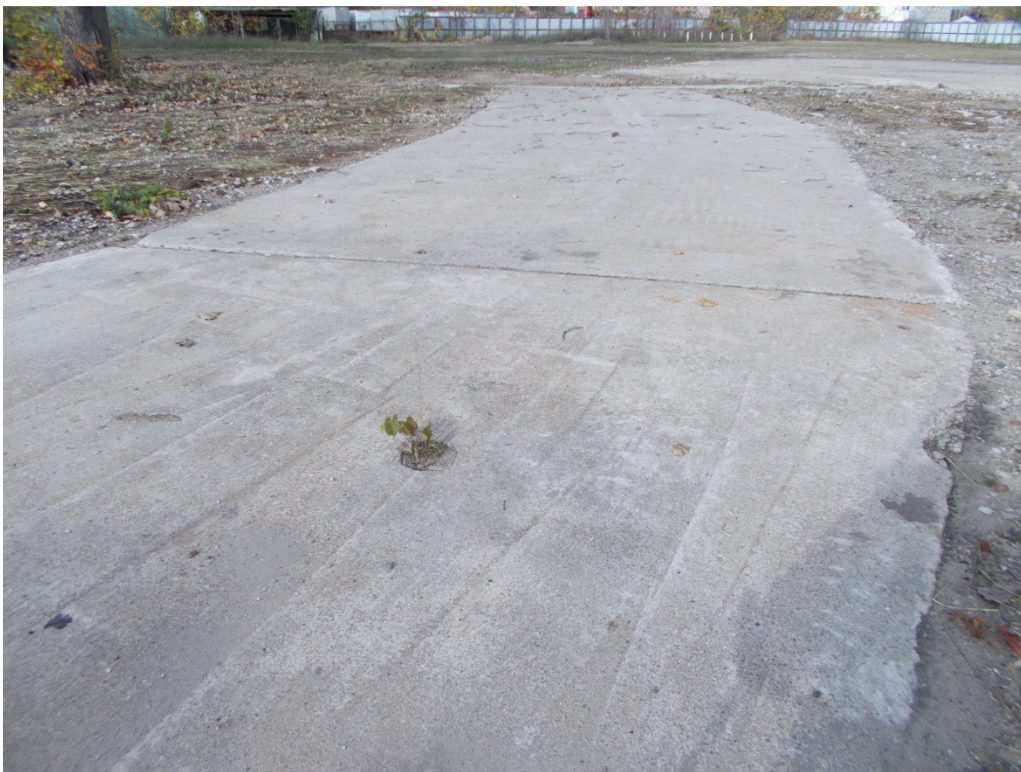
Designation: SA1-C-S03

- Cracking and other deterioration observed appears to be unchanged.
- The structure does not appear to have been impacted during sediment removal.

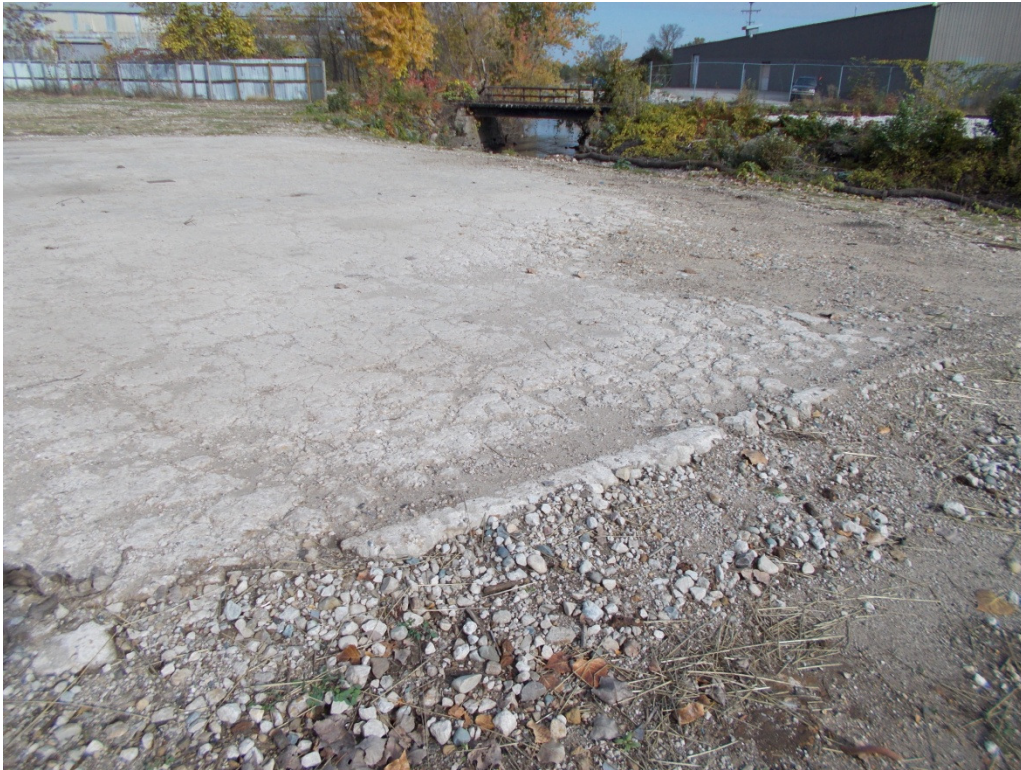
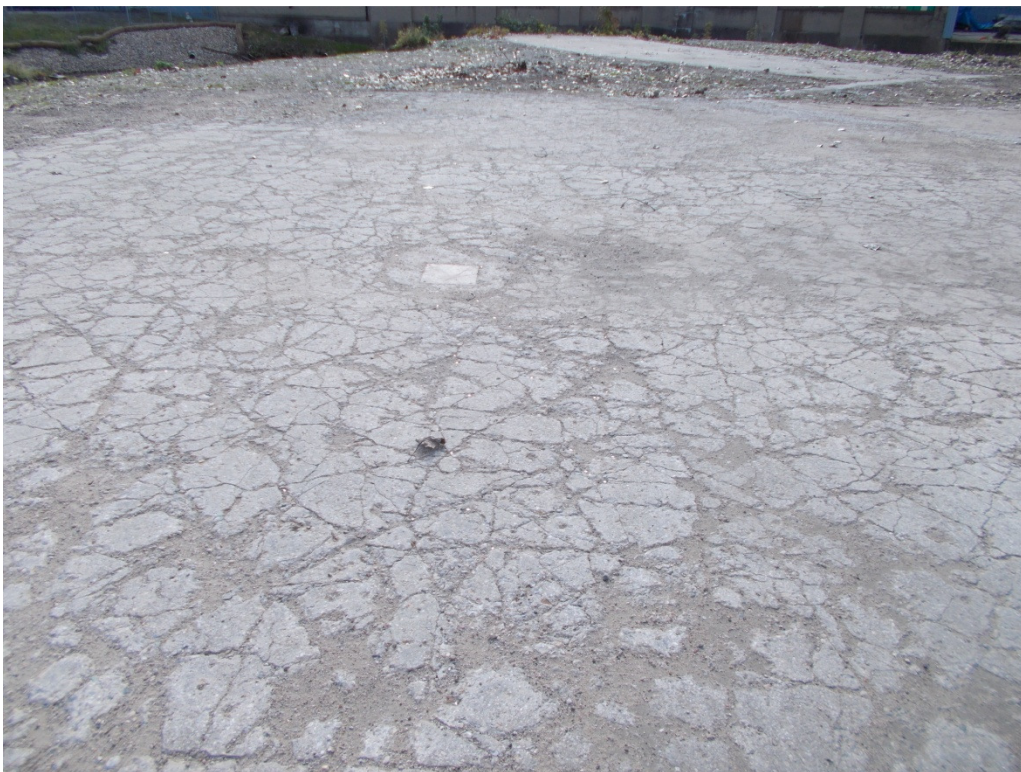
Designation: SA1-C-S05

- Cracking and other deterioration observed appears to be unchanged.
- The structure does not appear to have been impacted during sediment removal.

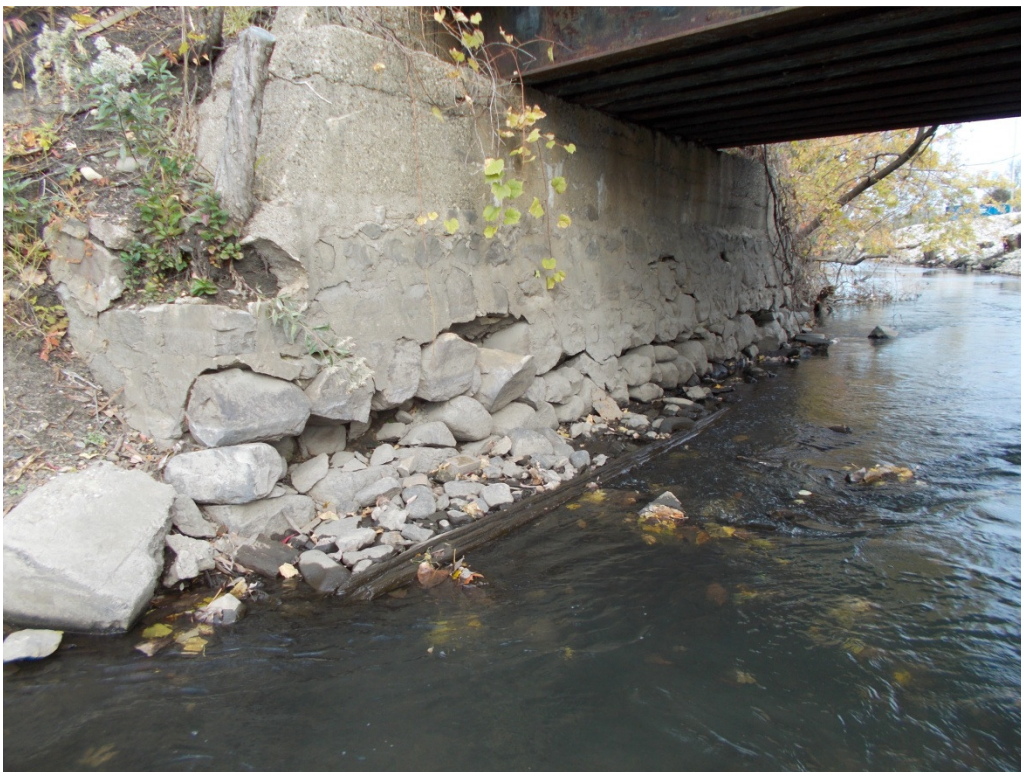
- Severe deterioration of lower area of west abutment was obscured by high water during Pre-Sediment Removal Structure Assessment. However, the deterioration does not appear to be related to the sediment removal work.
- The structure does not appear to have been impacted during sediment removal.

Severe deterioration of lower area of west abutment
